REPORT DOCUMENTATION PAGE		READ INSTRUCTIONS BEFORE COMPLETING FORM
1. REPORT NUMBER	2. AUTHOR ACCESSION NO.	3. RECIPIENT'S CATALOG NUMBER
4. TITLE (and Subtitle) Phase I Inspection Report Lake Moraine Dam Chenago River Basin, Madison County, New York Inventory No. 354		5. TYPE OF REPORT & PERIOD COVERED Phase I Inspection Report National Dam Safety Program

LAKE MORaine DAM

PHASE I INSPECTION REPORT
NATIONAL DAM SAFETY PROGRAM
NAME OF DAM - LAKE MORaine DAM ID# - NY 354

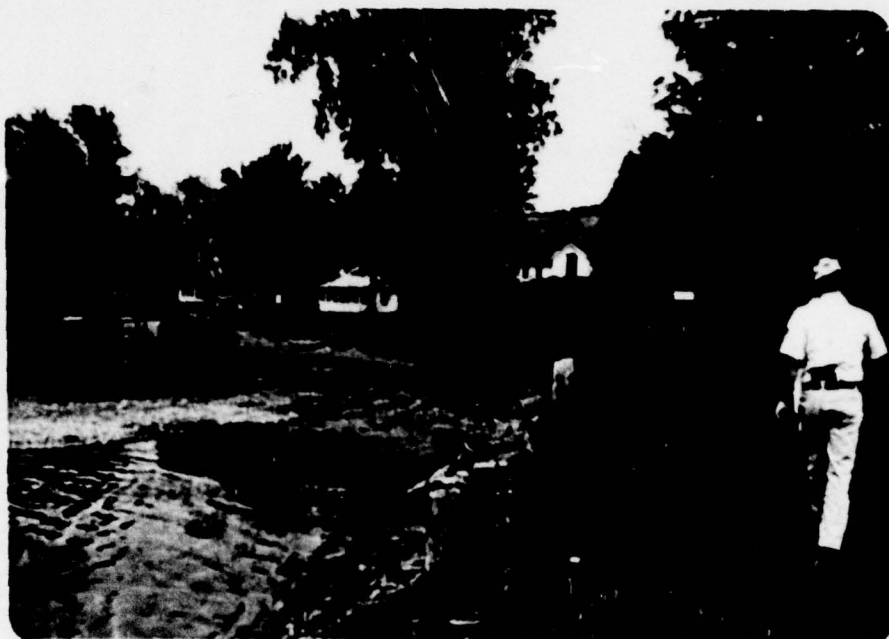
1. Summer and winter residences at the east end of the reservoir. These structures are located at an elevation below the top of the dam. Some flow could divert around the dam between the structures located in the left portion of this photograph.

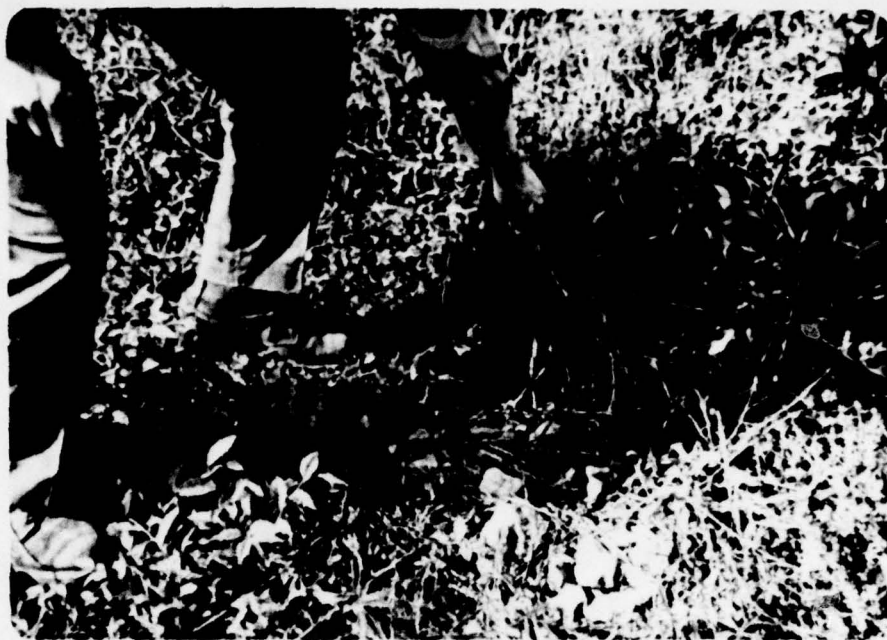
3. Close-up of stone drainage channel at toe of embankment. The toe area is overgrown with brush and grass type vegetation.

A poorly defined stone lined ditch runs parallel to the toe of the westerly portion of the dam. Some flowing water was observed in this ditch, although no specific source for this water was found. The inspection took place after a long spell of dry weather, so that it is unlikely that surface run-off would have caused this amount of flow. An abandoned outlet structure is located near the center of the easterly portion of the dam. There is no information regarding this structure. Water in the abandoned discharge channel near the outlet from this structure shows evidence of iron oxide precipitation.

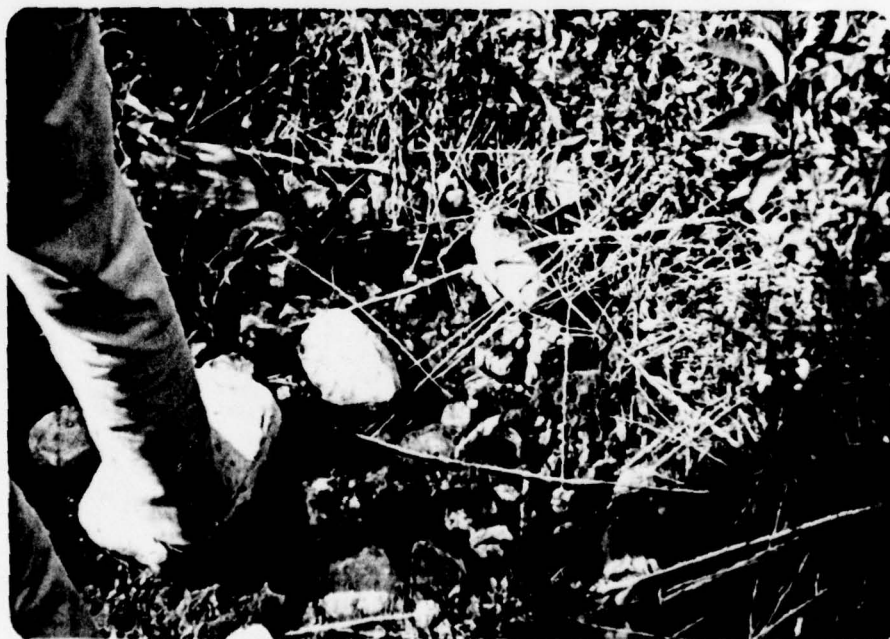
4. Close-up of wet area with slight amounts of seepage coming through toe of the east section abutment. This area is located near the center of the east embankment section.

The visual inspection indicates that seepage problems may exist on the easterly embankment section of the dam. Both the stone ditch area near the east abutment of this section and the wet spots on the face of the embankment near the west abutment should be investigated to determine the source of this moisture. An investigation should be undertaken to determine the condition of the abandoned outlet structure through the easterly section. Remedial work should be taken if this condition could endanger the stability of the structure. The riprap on both the east and west sections of the dam should be repaired and stumps along the waterline should be removed. The source of the problem causing the localized settlement in the downstream face of the dam just above the outlet structure should be investigated and remedial measures taken to rectify this problem.

Water flow believed to be through-the-dam seepage occurs at the downstream toe of the easterly dam section. Some damp and spongy areas also were noted at higher elevations on the downstream slope of this easterly segment. Two capped observation well pipes, recently installed by the State Department of Transportation, are in place and extend through the top of the embankment, presumably to obtain information on water levels in the embankment to relate to the noted seepage conditions.

2. Monitor the quantity and further investigate the source of under/through-the-dam seepage in the easterly embankment section.
3. Investigate the condition of the abandoned outlet structure in the easterly embankment and undertake remedial measures necessary to mitigate the effect of dangerous conditions which may exist.

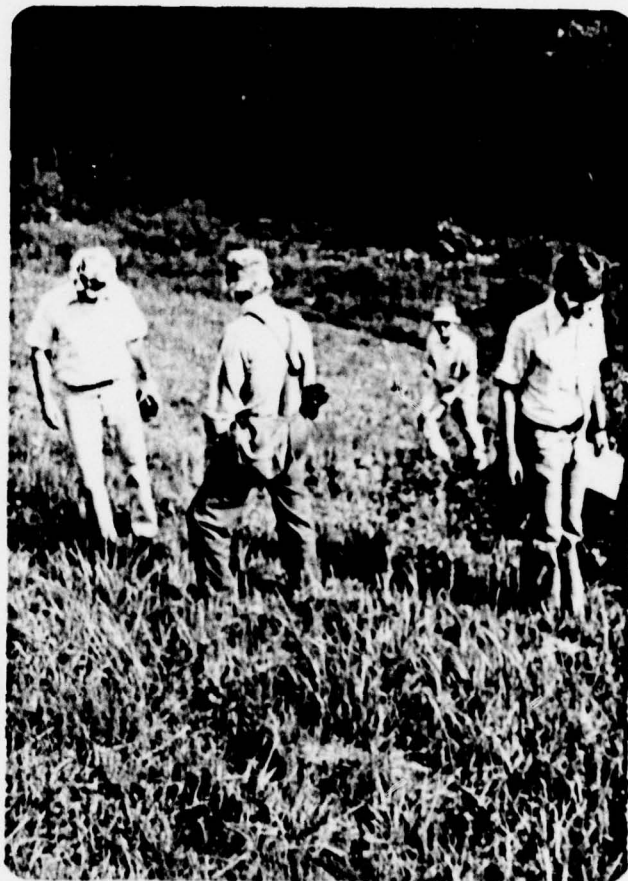
5. Inspection of another wet area on east section of dam at its west abutment at a distance one-third the way down from the top of the dam. The soft/wet area is between 200-500 square feet in area.

Two areas of suspected seepage were discovered near the west abutment of the easterly section of the dam. These areas were on the face of the dam at approximately 1/2 of the height of the dam. No flowing water was noted in these areas, however, definite evidence of moisture and spongy ground conditions were discovered.

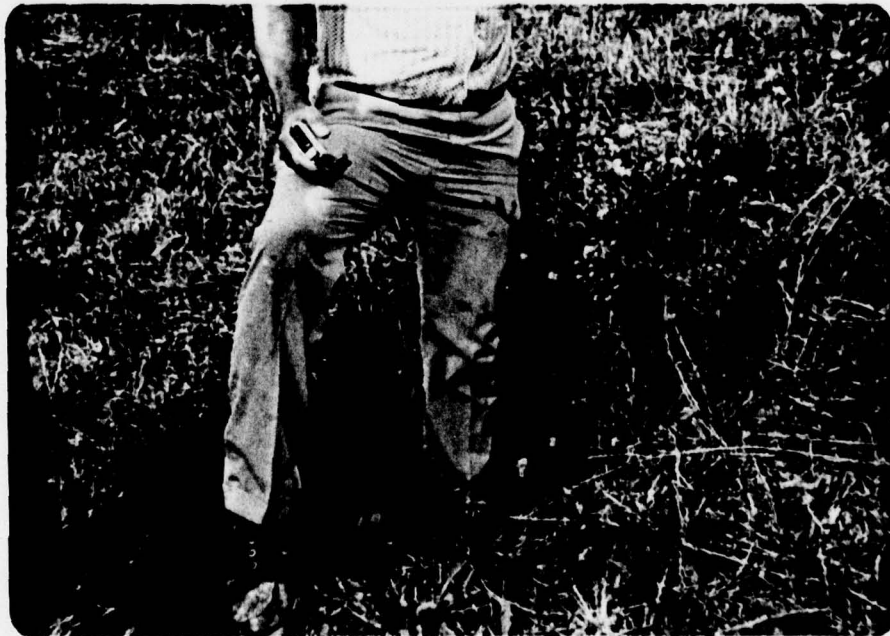
7. Hole location west dam section, less the 1/2 cubic yard in size. A number of animal holes have been located in the area. The origin of this hole is unknown.

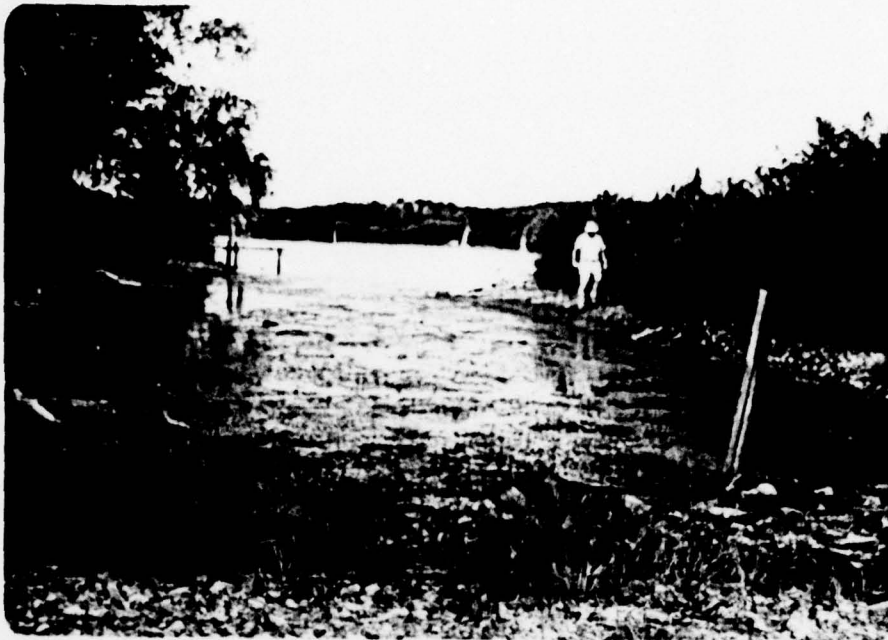
8. Note spillway entrance channel at west end of dam. The channel is not lined.

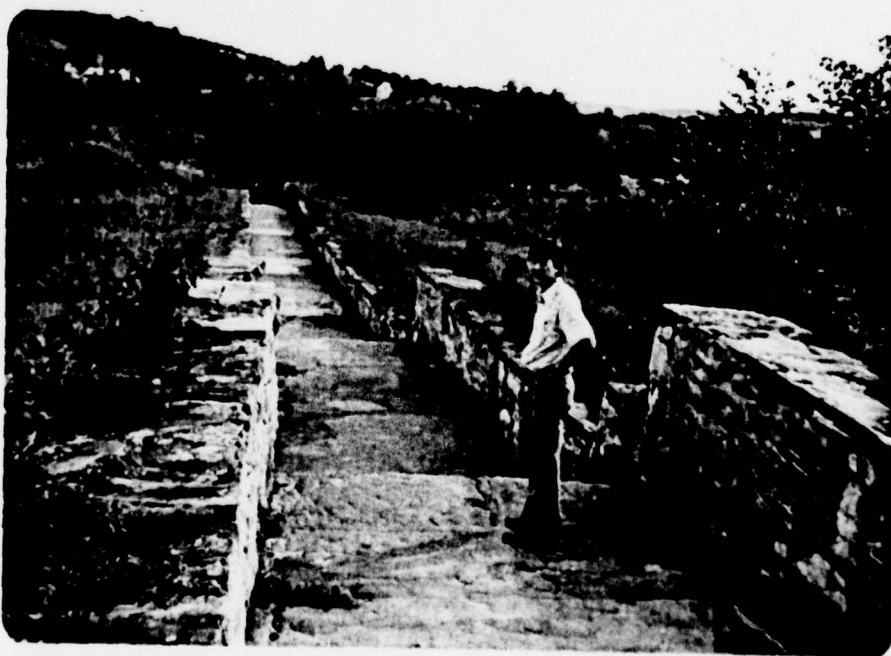
9. Spillway necks down from 35 feet to this 10 foot section.
